Manhole Inspection Summary

Manhole # S33EE_038MH

Location Address: **1225 PRESTON ST**

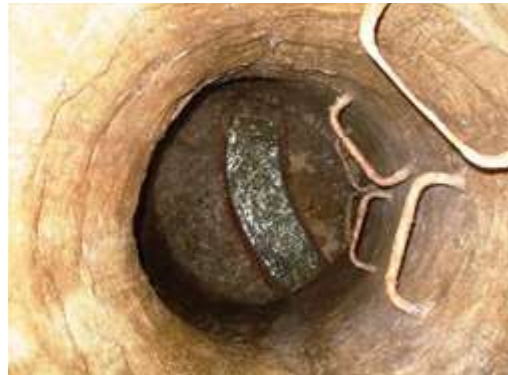
Top View

Corroded and missing steps. Bench debris.

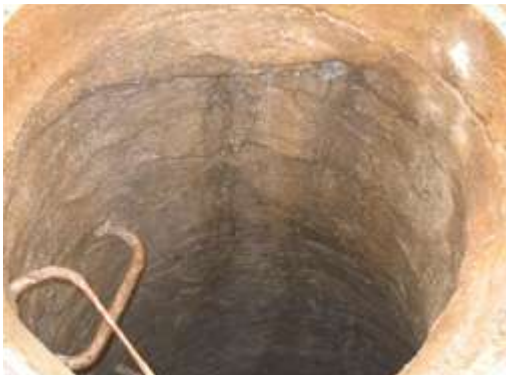
Defect

Frame leaks. Adjustment infiltration.

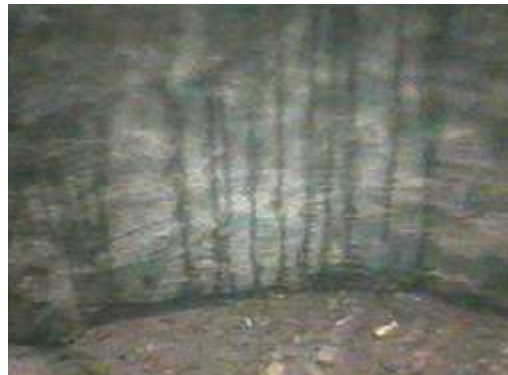
Defect

Barrel infiltration.

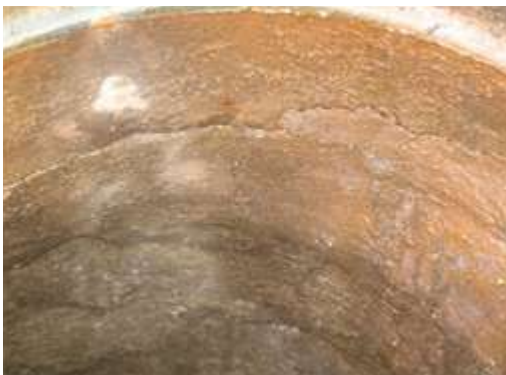
Defect

Frame leaks. Adjustment infiltration.

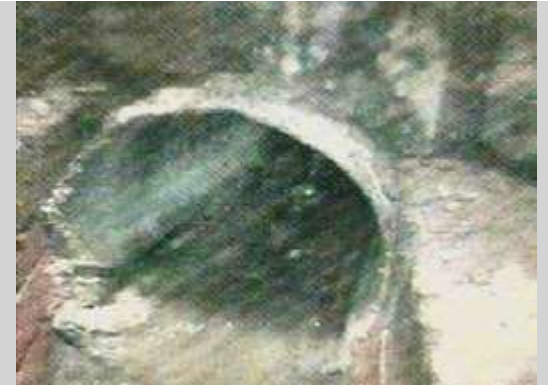
15 in. Circular Gravity Sewer Pipe Out @ 12 O'Clock

Deposits: ☐ None ☒ **Mud** ☐ Sludge ☒ **Debris** ☒ **Grease**

Silt Depth: **0.5** (in.) Deposits Extent: **Light**

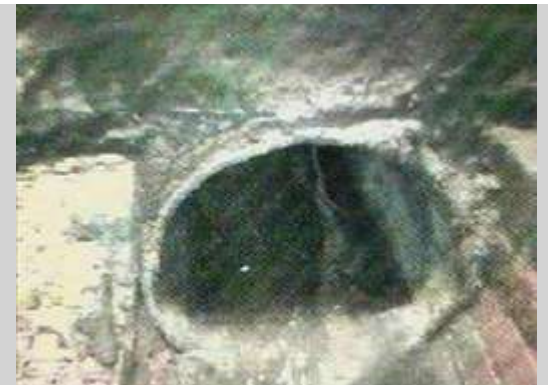
15 in. Circular Gravity Sewer Pipe In @ 5 O'Clock

Deposits: ☐ None ☒ **Mud** ☐ Sludge ☒ **Debris** ☒ **Grease**

Silt Depth: **0.5** (in.) Deposits Extent: **Light**
